MISCELLANEOUS PAPER S-73-44

CONDITION SURVEY, FORBES AIR FORCE BASE, KANSAS

June 1973

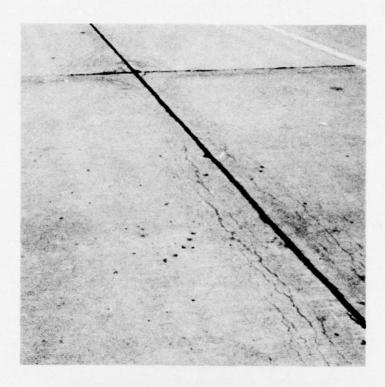
Photo 1. "D" cracking on parking apron

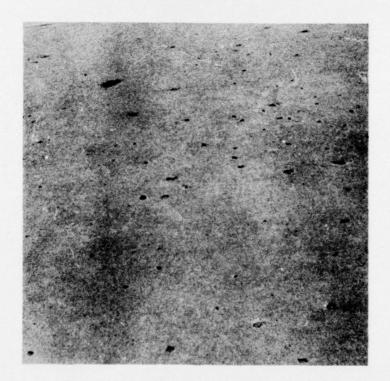
Photo 2. Pop-outs on parking apron

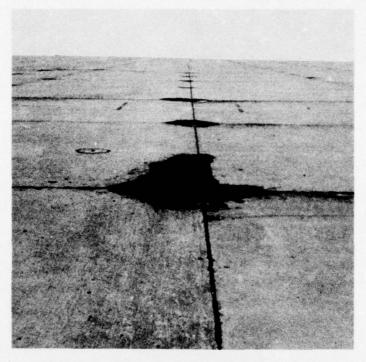
Photo 3. AC repairs at slab corners of parking apron

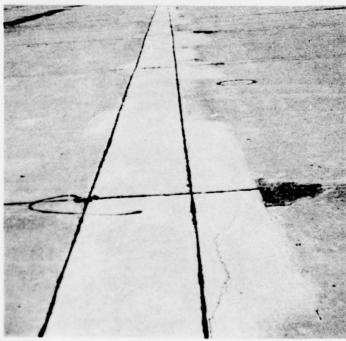
- 14. The parking aprons were in very good condition, even though the number of major defects had increased considerably since the 1960 survey. The distressed area along the east side of the apron north of taxiway 2 referred to in the 1965 condition survey was overlaid with asphaltic concrete (AC) in 1969. This area was in very good condition, even though there was some reflection cracking. Another area referred to in the 1965 survey, located along the east side of the parking apron between taxiways 3 and 4, was overlaid in 1969 with AC in some areas and with tar rubber (TR) in other areas. Even though some reflection cracking had begun in this area, it was in very good condition. In 1971, a portion of the parking apron was overlaid with TR to cover an area that contained a considerable amount of "D" cracking and a large number of spalls. The remainder of the parking apron was in good to very good structural condition, even though "D" cracking and pop-outs were prevalent (photos 1 and 2). Photo 3 shows AC patches at the corners of slabs of the parking apron. Portland cement concrete (PCC) patches along joints in the apron (photo 4) had been placed to repair areas that contained "D" cracking.

Photo 4. PCC repairs along joints in parking apron
